UNDERWATER BRIDGE INSPECTION REPORT

STRUCTURE NO. 5270

RED RIVER OF THE NORTH

MINNESOTA DEPARTMENT OF TRANSPORTATION
UNDERWATER BRIDGE INSPECTION

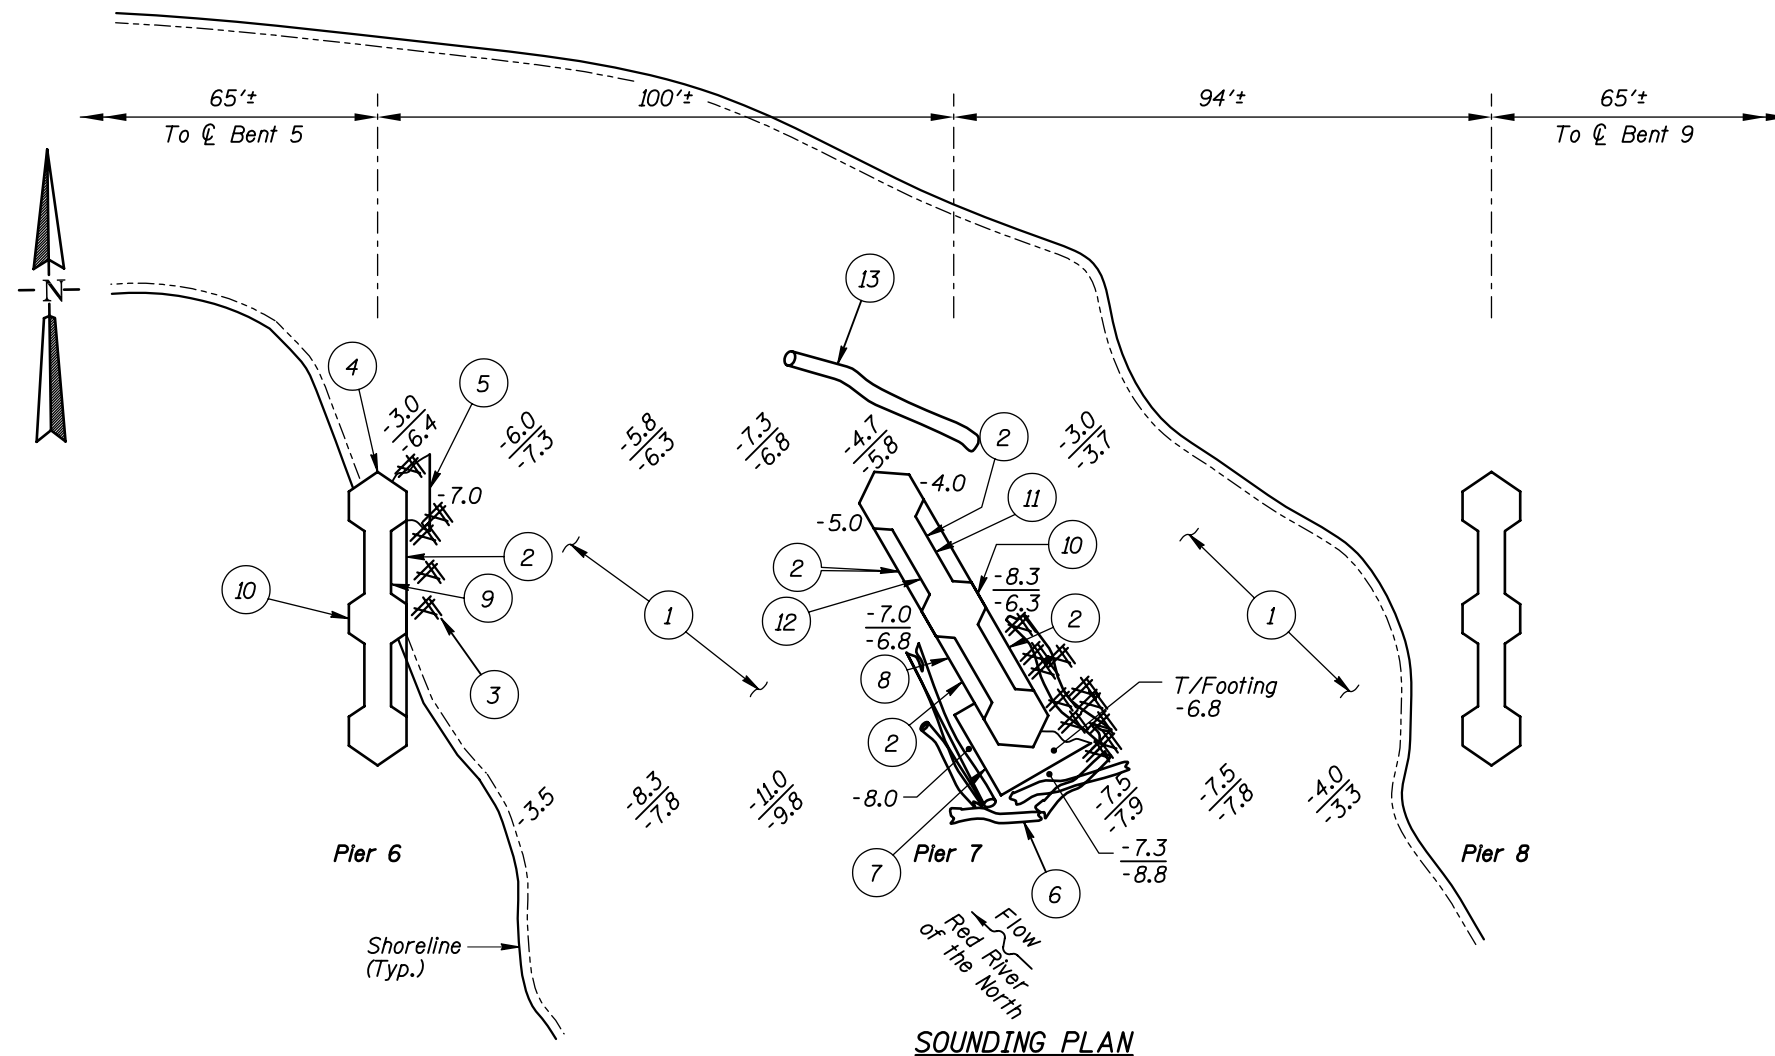
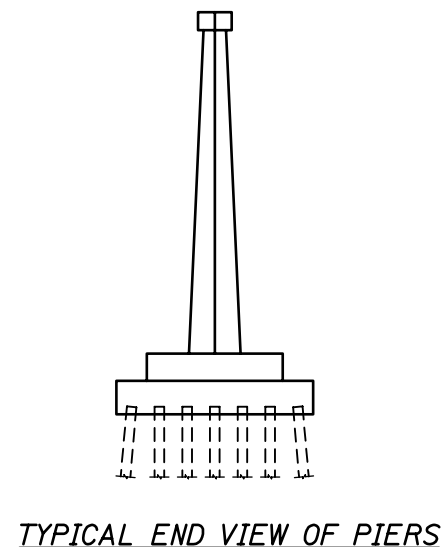
INSPECTION AND SOUNDING PLAN

- 1 The channel bottom material consisted of cobbles, rocks, and concrete rubble up to 2 feet in diameter.
- 2 The bottom portion of the concrete diaphragm was exposed 4.5 feet below the waterline on both sides of the pier between the columns.

- 3 Light accumulation of timber debris around Pier 6 on top of the pier cap.
- 4 Moderate scaling, 2 feet wide, 1 foot high with 3 inches of penetration was located at the waterline on the east side of the pier with exposed reinforcing steel exhibiting less than 10 percent section loss.

- 5 The downstream column footing was exposed with up to 6 inches of vertical exposure.
- 6 Moderate accumulation of timbers and timber debris around the upstream nose of Pier 7 extending up to the midpoint of the pier on both sides. Timber sizes were up to 12 inches in diameter.

- 7 Exposed footing, located 6.8 feet below the waterline, with up to 1 foot of vertical face exposure.
- 8 The bottom of the concrete diaphragm was undermined with up to 6 inches of vertical height.

- 9 A vertical crack was observed, up to 1/8 inch wide, extending from waterline to top of cap.
- 10 Light to moderate scaling with 1/8 inch typical penetrations and 1/2 inch maximum penetrations was observed from 6 feet above the waterline to the channel bottom on Piers 6 and 7.

- 11 A vertical hairline crack was observed from 2 feet above the waterline to the waterline.
- 12 A vertical hairline crack was observed in the webwall.

- 13 18 inch diameter log was embedded in the channel bottom by its root ball.

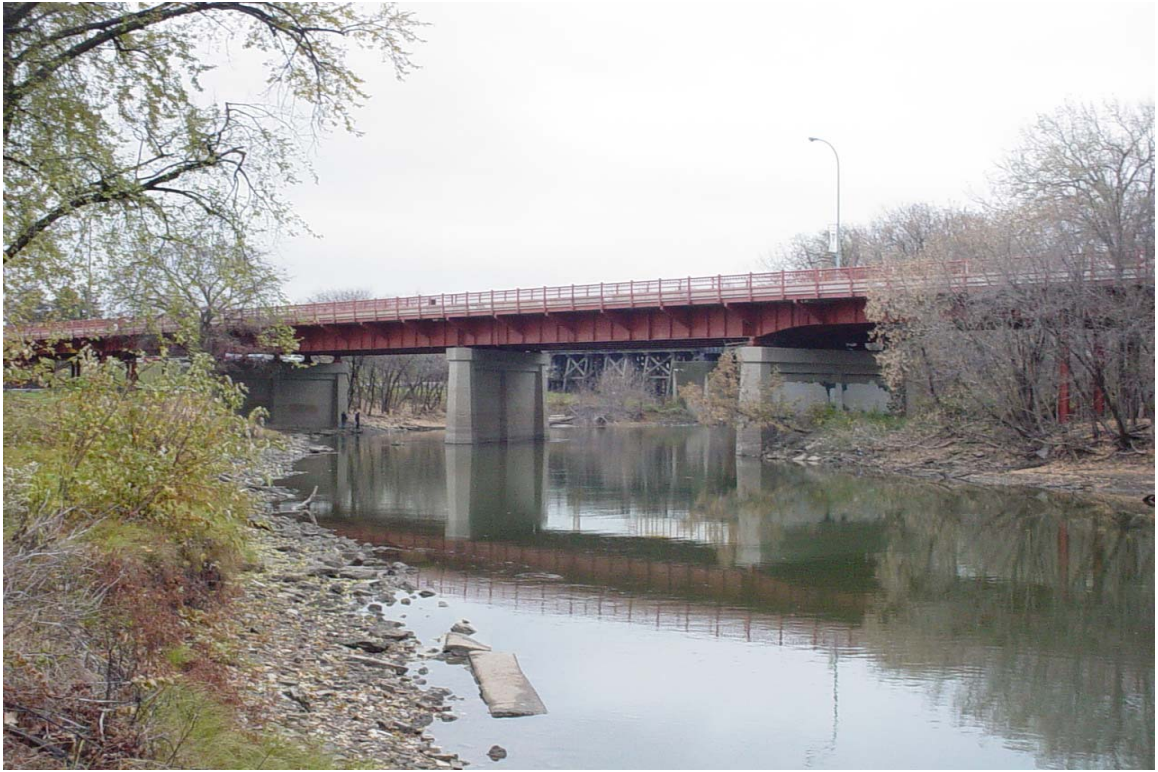
Photograph 1. Overall View of the Structure, Looking South. Note the Pier's Angle of Attack at Bridge.

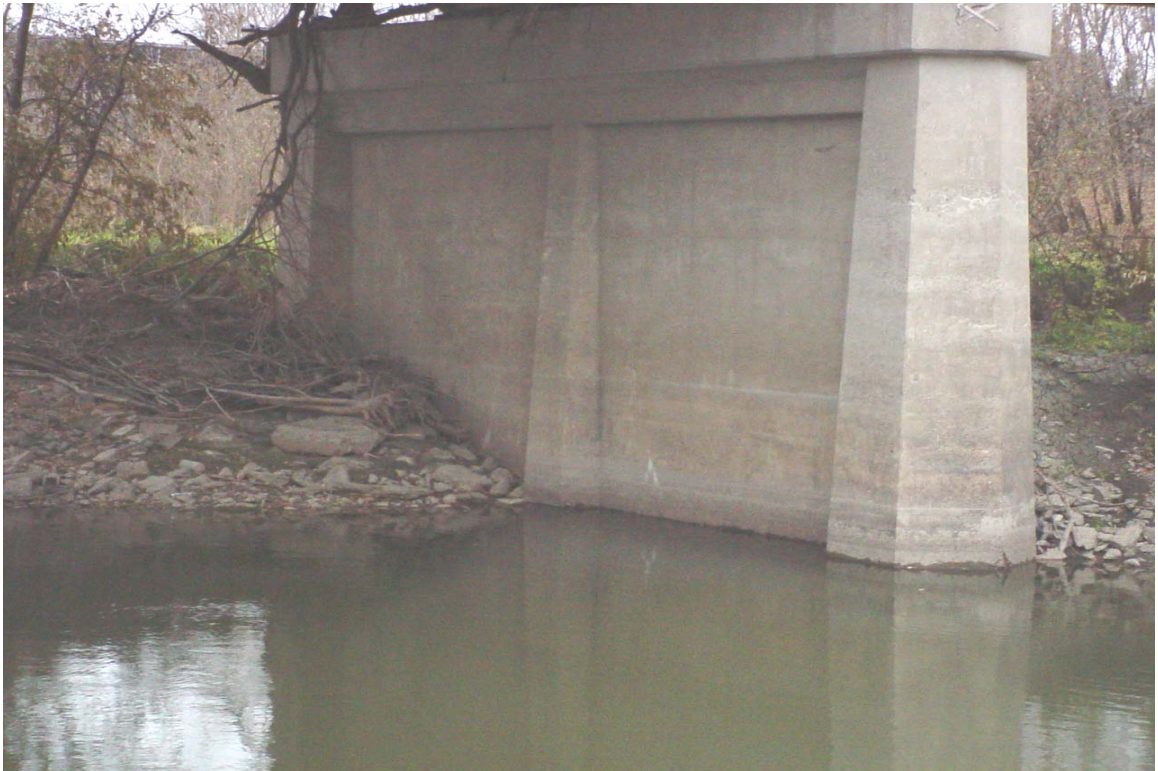
- (C) Light to moderate scaling with 1/8 inch typical penetrations and 1/2 inch maximum penetrations was observed on Piers 6 and 7 from 6 feet above the waterline to the channel bottom. There was also some 3 inch deep scaling with exposed reinforcing steel on the downstream nose of Pier 6.

- (D) A light accumulation of timber debris was present around Pier 6 on top of the pier cap indicating that water levels have at some point exceeded the pier height.

Photograph 2. View of Pier 6, Looking West.

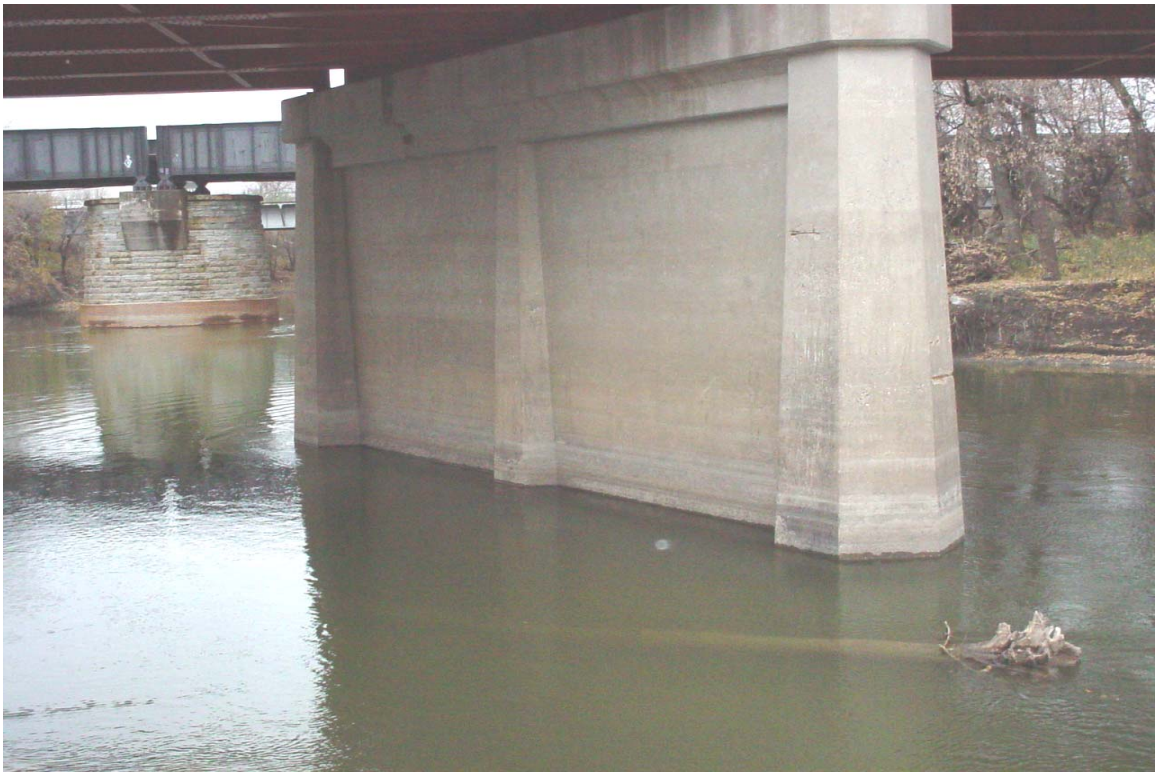
- (E) A moderate accumulation of timber debris, consisting of logs and branches up to 12 inches in diameter, was observed extending from the upstream nose to the midpoint of Pier 7. An 18 inch diameter log embedded in the channel bottom by its root ball was located at the downstream end of Pier 7.

Photograph 3. View of Pier 7, Looking Southwest. Note Timber Log in the Forefront that was Embedded in the Channel Bottom.

Monitor the accumulations of timber debris at Piers 6 and 7 during future inspections, and if found to be increasing, removal operations may become warranted.
